Information on Status of Nuclear Power Plants in Fukushima

Japan Atomic Industrial Forum, Inc.

Status of nuclear power plants in Fukushima as of 10:00, April 2nd (Estimated by JAIF)

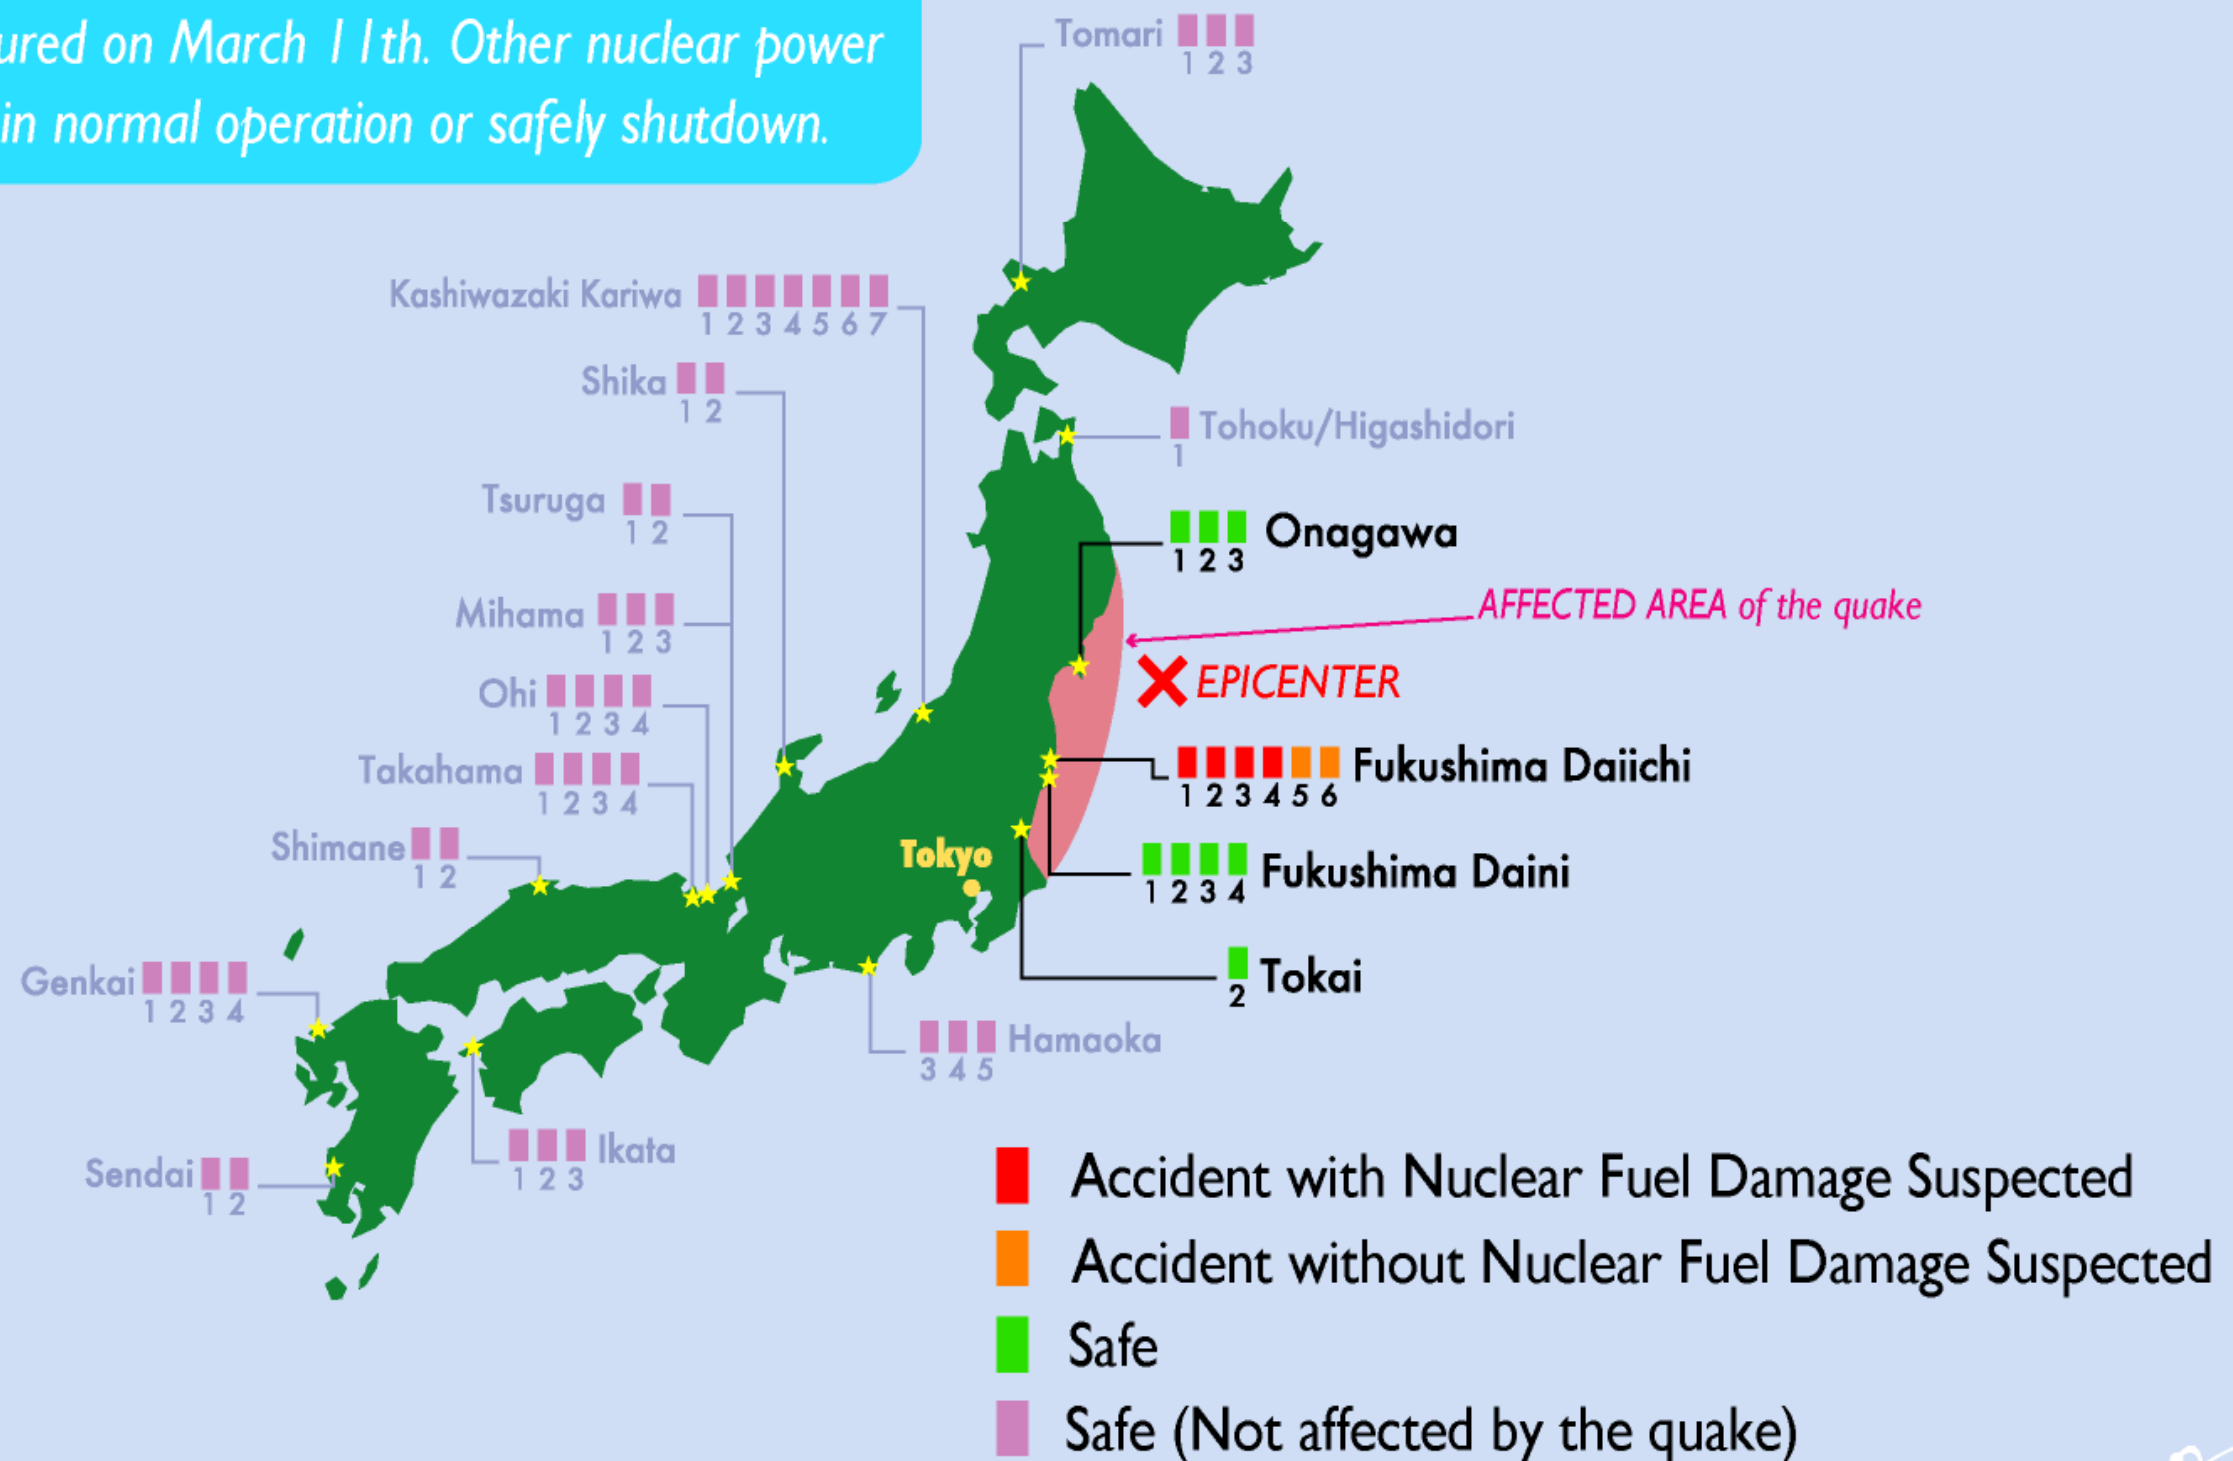
Status of the Nuclear Power Plants after the Earthquake

The accident that brings environmental impact is going on at several units in Fukushima Daiichi nuclear power Station after the earthquake occurred on March 11th. Other nuclear power plants in Japan are in normal operation or safely shutdown.
